QUINNIPIAC RIVER BASIN
CHESHIRE, CONNECTICUT

MIXVILLE POND DAM
CT 00302

PHASE I INSPECTION REPORT
NATIONAL DAM INSPECTION PROGRAM

FEBRUARY, 1981
84 08 09 080

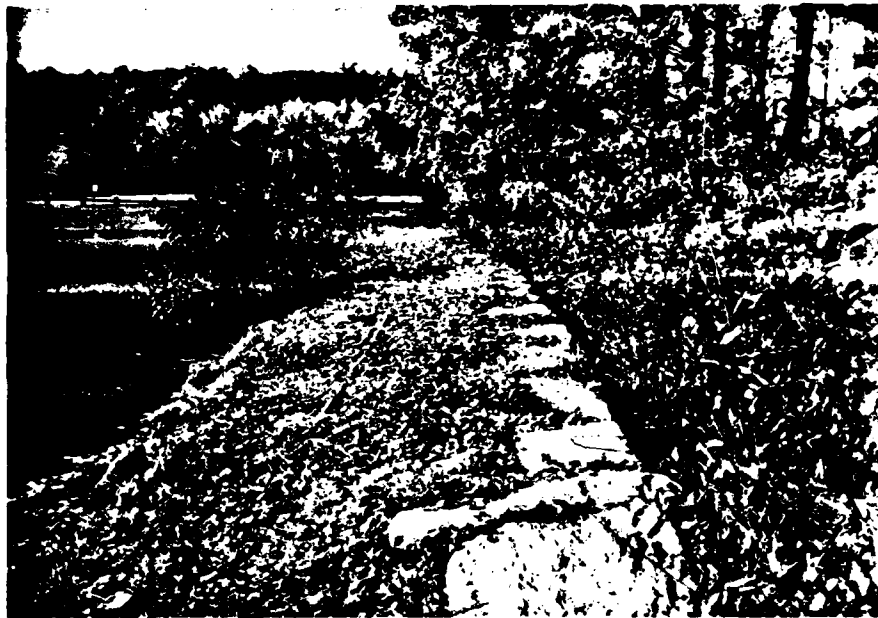
PHOTO 1

TOP OF DAM LOOKING WEST
